Special Report 78-17

September 1978

EFFECTS OF WINTER MILITARY OPERATIONS ON COLD REGIONS TERRAINS

Prepared for
DIRECTORATE OF FACILITIES ENGINEERING
OFFICE, CHIEF OF ENGINEERS

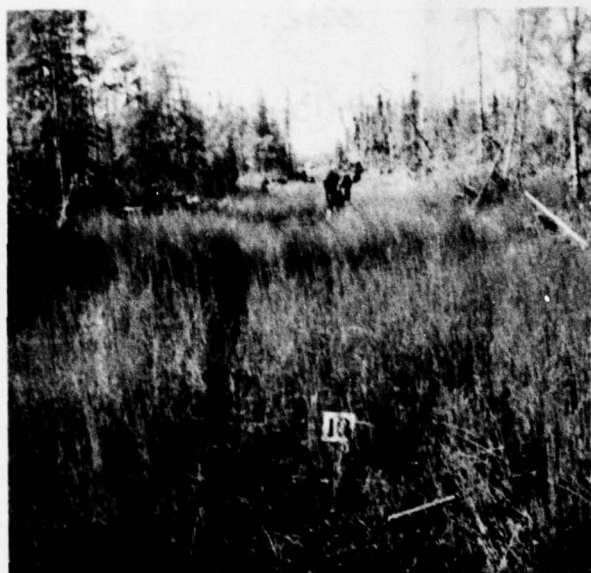
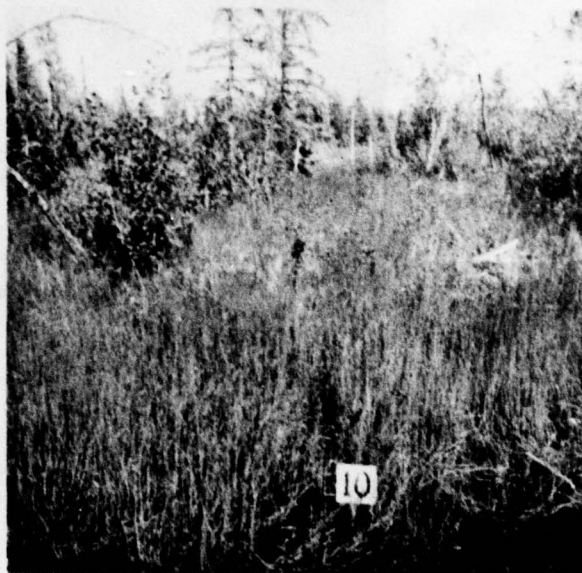
Site 10 (Figs. 6 and 7) A poorly drained, open black spruce and tamarack stand with a patchy shrub understory of willow and resin birch and a high percentage cover of sedges and grasses, primarily cottongrass, bluejoint reed-grass and common herbaceous horsetail.

Most of the surface vegetation had been removed by the bulldozer blade down to the surface of the organic soil. Since many roots and rhizomes were left in place, rapid sedge and grass regrowth has occurred within the trail. Thaw depth in the trail was approximately 1 m, and in the adjacent undisturbed area approximately 80 cm.

Figure 6. Site 10
(looking N).

Figure 7. Area adjacent to site 10
(looking E).

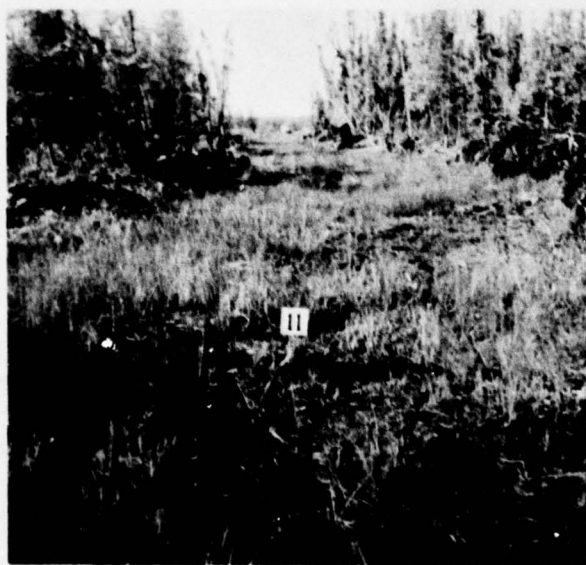
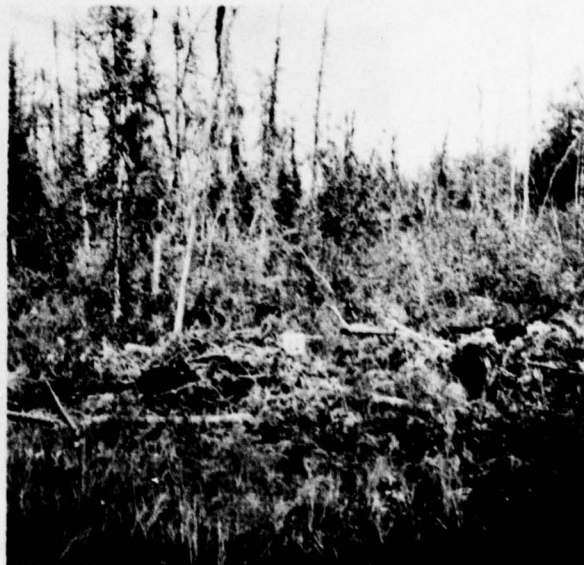
Site 11 (Figs. 8 and 9). Similar to site 10, except better drained with more continuous layer of black spruce and a few tamarack and almost complete cover by shrub understory of resin birch, buffaloberry and willow.

Trees and shrubs had been removed along with their roots, exposing large areas of organic soil. The revegetated grass cover on the trail varied from 1 to 80%, consisting mainly of cottongrass and a few tussock cottongrass with some bluejoint reedgrass and horsetail. Thaw depth in the trail was approximately 1 m, and in the adjacent area 90 to 95 cm.

Figure 8. Site 11
(looking N).

Figure 9. Area adjacent to site 11
(looking E).

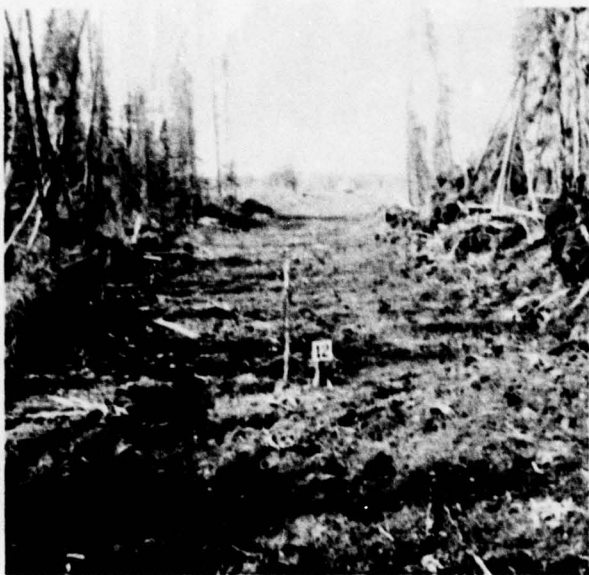
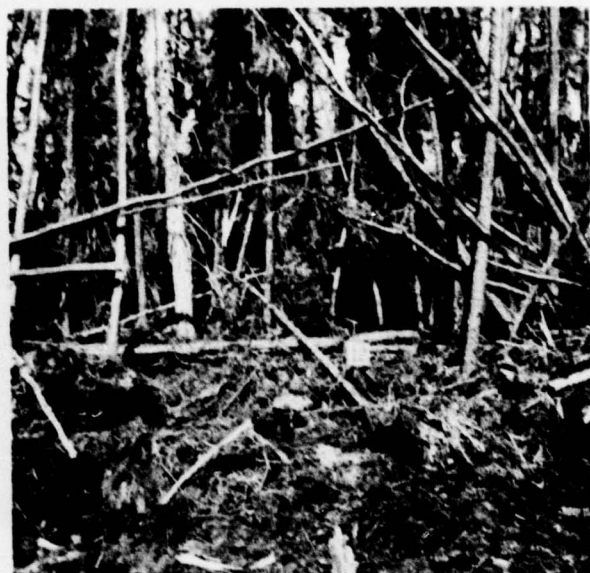
Site 12 (Figs. 10 and 11). Drier than the previous two sites with a 5 m (approx.) black spruce overstory, a few taller willows and an extensive low shrub understory of labrador tea, bearberry, low bush cranberry and prickly rose, and a moss ground cover.

Because of the overstory density, removal of the trees with their roots had resulted in nearly complete removal of the surface vegetation mat, exposing dry organic soil. Vegetation cover on the trail was less than 10%, consisting of scattered seedlings of cottongrass. Some scattered debris from the trees remained on the trail surface. The thaw depth probe penetrated only 70 cm to what appeared to be gravel, not the frost line.

Figure 10. Site 12
(looking N).

Figure 11. Area adjacent to site 12
(looking E).

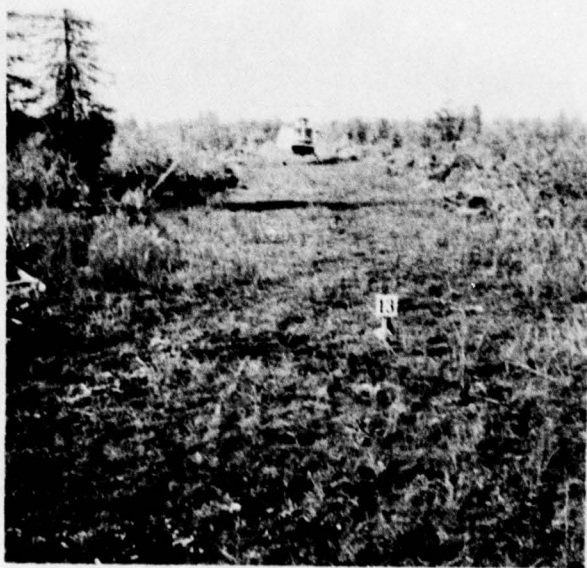
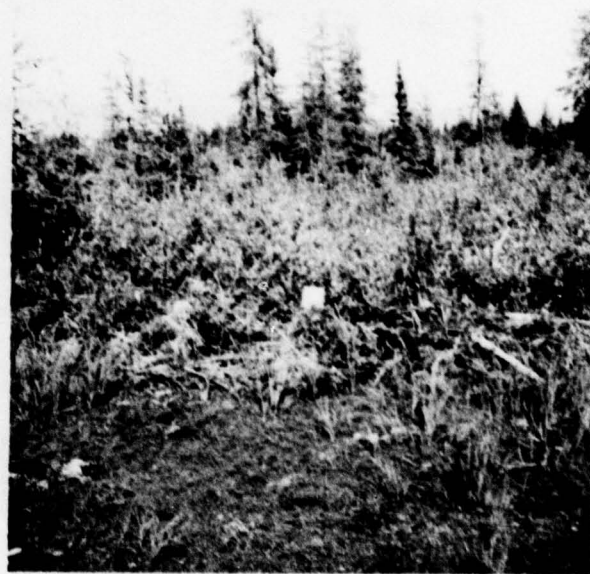
Site 13 (Figs. 12 and 13). A willow shrub thicket with scattered tamarack, resin birch, moss hummocks, bluejoint reedgrass and sedge.

The trail cut had been done with very little penetration of the bulldozer blade into the soil. Revegetation had produced a 20% vascular plant cover over the dried organic soil, the prominent species being tussock cottongrass, bluejoint reedgrass, horsetail, sedge and some willow. What appeared to be either the frost line or gravel was detected at a depth of 80 cm.

Figure 12. Site 13
(looking N).

Figure 13. Area adjacent to site 13
(looking E).

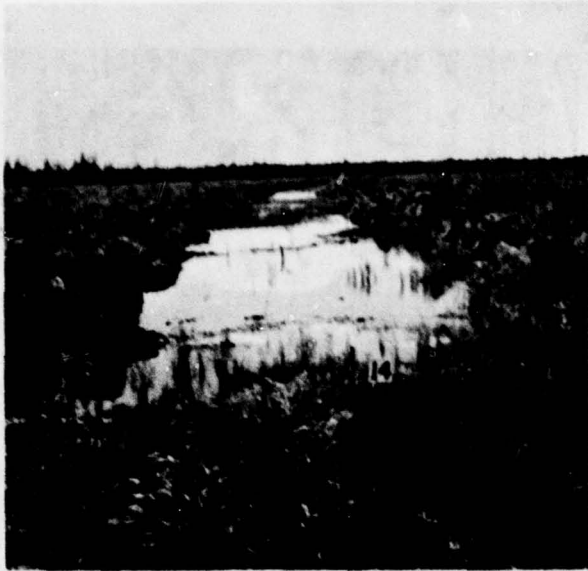
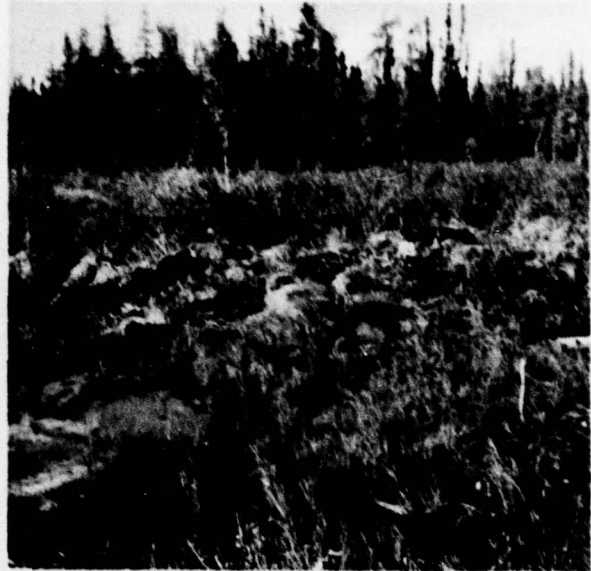
Site 14 (Figs. 14 and 15). A poorly drained, well developed shrub-tussock community with cottongrass tussocks up to 1 m in diameter, scattered paper birch with numerous resin birch and willow species; species frequently occurring on the tussocks include cloudberry, labrador tea, and blueberry, as well as mosses.

Blade penetration had been down to the bottom of tussocks, near the natural water level. The vegetation cover was less than 10%, primarily bluejoint reedgrass and horsetail, with exposed, wet organic soil and ponded water elsewhere. Thaw depth in the trail was 60 to 65 cm, and 35 to 40 cm in the adjacent area (measured from the bottom of tussocks).

Figure 14. Site 14
(looking N).

Figure 15. Area adjacent to site 14
(looking E).

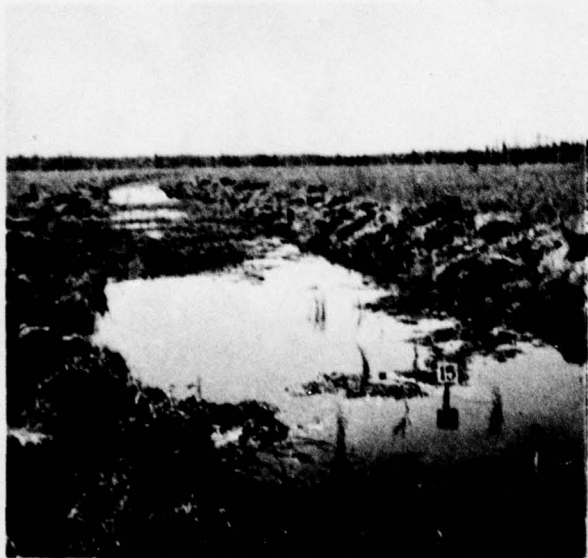
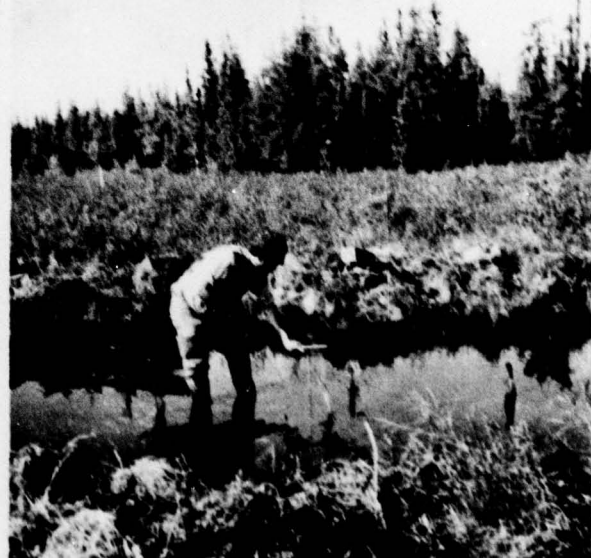
Site 15 (Figs. 16 and 17). Same original vegetation cover as at site 14.

At this location, blade penetration had been several cm below the bottom of tussocks, resulting in standing water, up to 10 cm deep, in the trail. Some bluejoint reedgrass and iris were observed in the water. Thaw depth was 70 cm below the water surface, and 31 to 36 cm in the adjacent area (measured from the bottom of tussocks). This site represents one of the deepest disturbances on the new trail, in terms of bulldozer blade penetration.

Figure 16. Site 15
(looking N).

Figure 17. Area adjacent to site 15
(looking E).

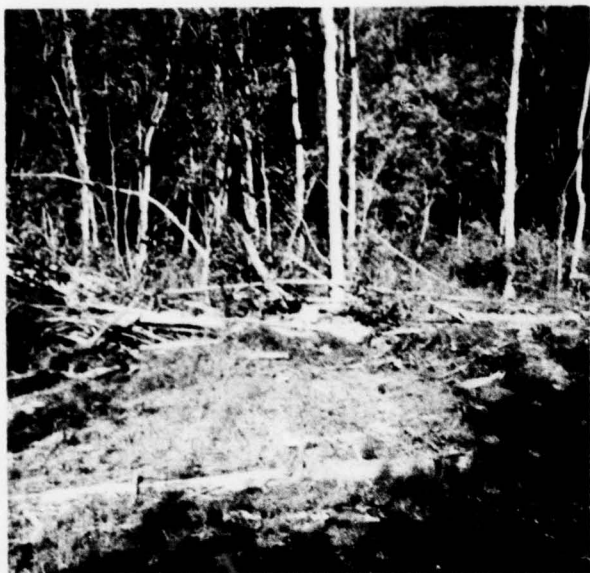
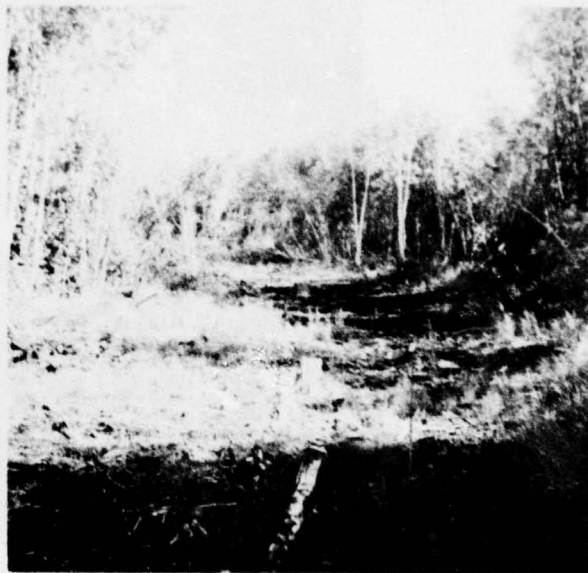
Site 16 (Figs. 20 and 21). A mixed paper birch (dominant) - white spruce stand with a tall understory of alder and willow (approx. 5 m.), indicating a relatively young stand.

Trees and other vegetation had been removed to a level even with the terrain surface. Some trees had been uprooted, exposing wet organic soil. Vegetation cover varied from 10 to 90% over the area, the dominant species being bluejoint reedgrass and horsetail with numerous willow seedlings. Thaw depth was greater than 1 m.

Figure 20. Area adjacent to site 16
(looking E).

Figure 21. Site 16
(looking S).

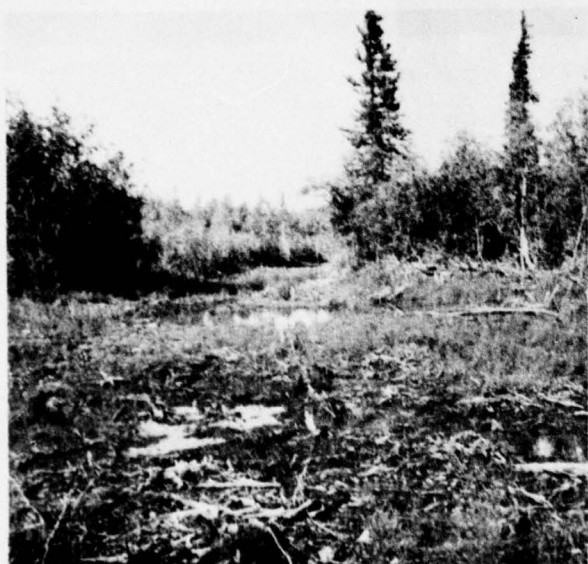
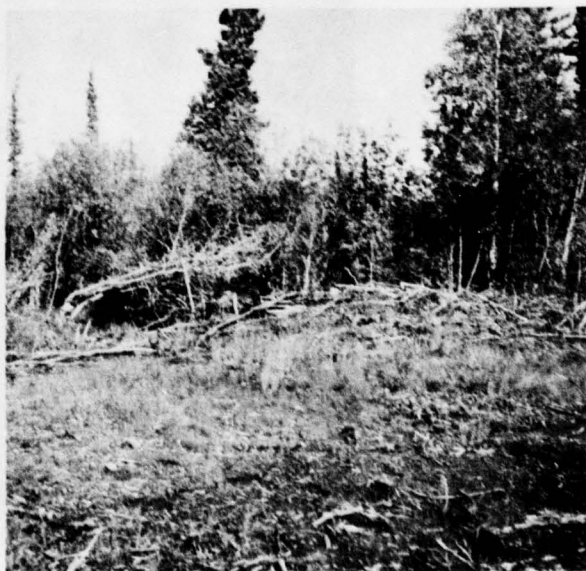
Site 17 (Figs. 22 and 23). A tall (5-m) alder-willow shrub community (similar to the understory at site 16), with a few paper birch and white spruce.

The surface disturbance was more severe than at the nearby site 16. Blade penetration and uprooting of some of the trees had resulted in several depressions deep enough to expose standing water. Vegetation cover varied from 0% in the exposed water areas to 80% in the drier, less disturbed locations, and included bluejoint reedgrass, horsetail, fireweed, prickly rose and bunchberry. Thaw depth was greater than 1 m.

Figure 22. Site 17
(looking N).

Figure 23. Area adjacent to site 17
(looking E).

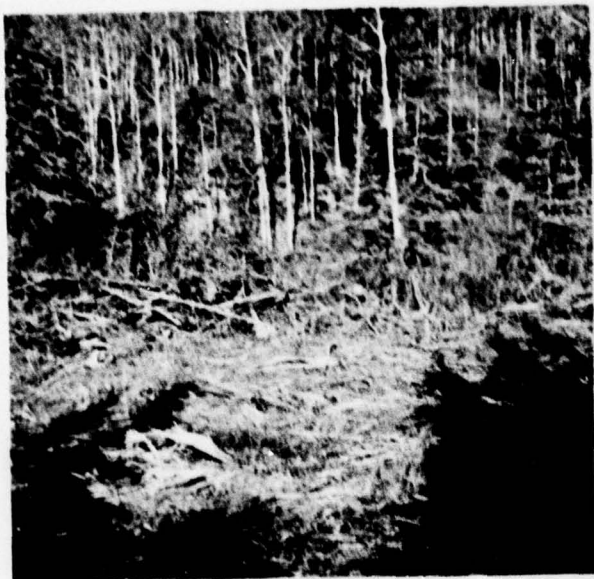
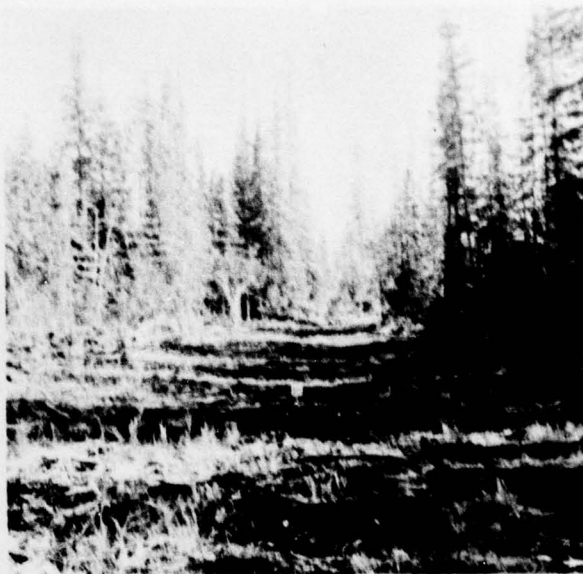
Site 18 (Figs. 26 and 27). A mixed spruce-birch stand, similar to site 16, but better drained, with a 10% vascular plant cover, consisting of fireweed, winter cress, horsetails, sedges and scattered willows.

Disturbance has been comparable to that at site 16, with vegetation removed even with the terrain surface, exposing organic soil at intermittent locations. This site had been used for vehicle repair and maintenance.

Figure 26. Area adjacent to site 18
(looking E).

Figure 27. Site 18
(looking S).

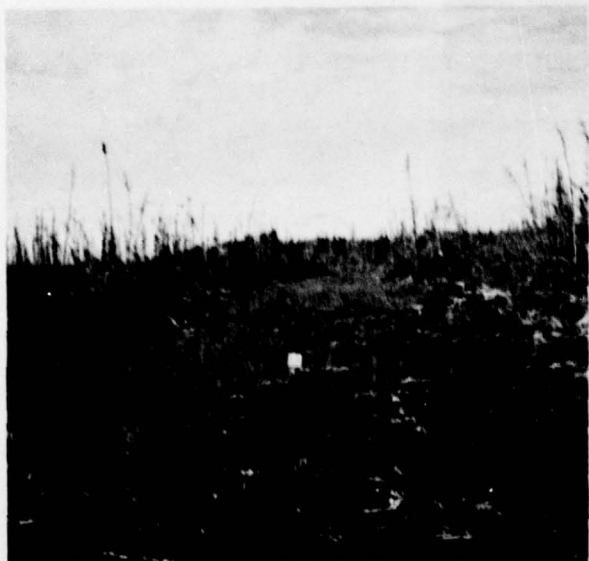
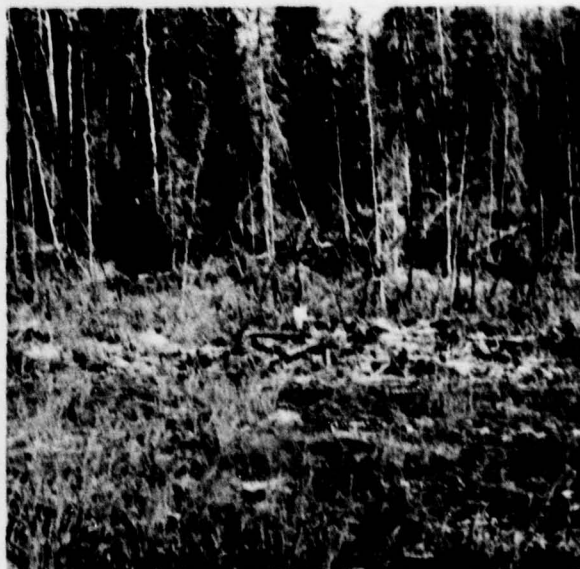
Site 19 (Figs. 28 and 29). A stand of dead spruce with a low shrub understory (primarily willow) in a well drained area.

Blade penetration had been even with or slightly below the soil surface, resulting in areas of exposed, dry organic soil. Revegetation by grasses and willow seedlings had produced a cover of less than 50% of the trail surface. This site was later burned out during a forest fire.

Figure 28. Site 19
(looking N).

Figure 29. Area adjacent to site 19
(looking E).

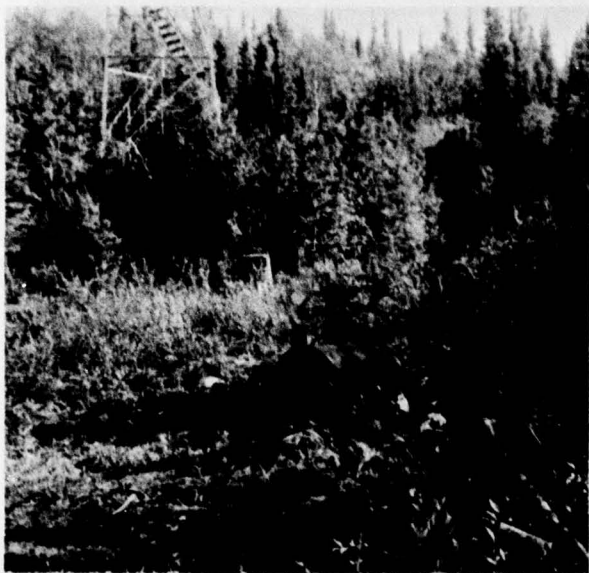
Some debris were found near the tower (Fig. 36), indicating troop activities, but generally the area had been cleaned up very well.

Figure 36. Troop concentration
(artillery) area.

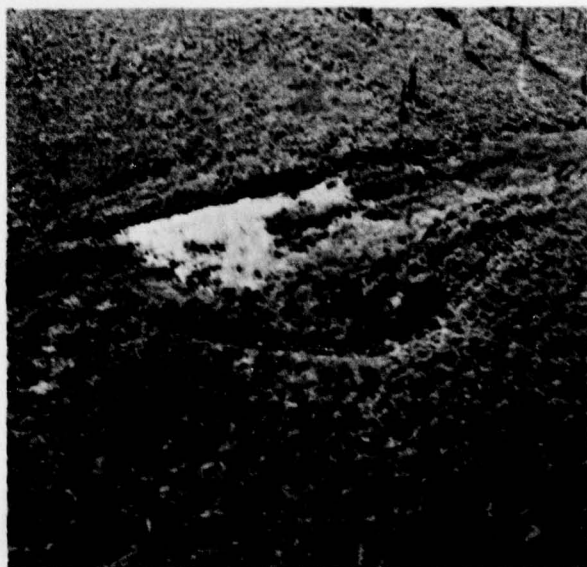
The beginning of the trail on the west bank of the river is shown in Figure 60, and the continuation of the trail toward west in Figures 61 through 67. In one poorly drained area (Fig. 65), vehicle trails were observed off the original trail which showed noticeable subsidence and had resulted in a depression below the water level. Ground inspection was made at one location on the trail to observe the vegetation regrowth (Figs. 68 and 69).

Figure 65. Trail through wet area.
